**CAPITAL RESERVE ANALYSIS**  
FOR  
**SMYRNA GROVE**  
SMYRNA, GEORGIA

SMYRNA GROVE HOMEOWNERS ASSOCIATION, INC.  
C/O CONDOMINIUM CONCEPTS MANAGEMENT, INC.  
1200 LAKE HEARN DRIVE, SUITE 275  
ATLANTA, GEORGIA 30319

NOVEMBER 2018  
REVISED: APRIL 2019

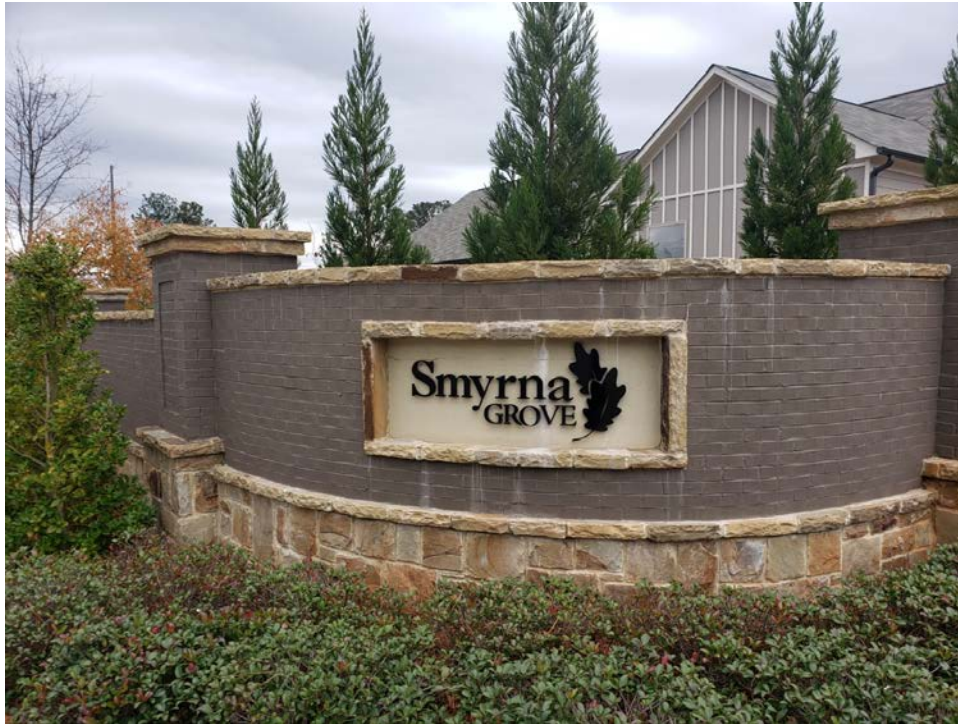
4. **Entry Monuments and Signage** – The entry monuments and signage consist of brick veneer piers with stone accents that support the entry gates and sections of metal picket fencing, and multiple brick veneer monuments with painted raised metal lettering. From our review, the entry monuments and signage appeared to be in generally good condition and well maintained (reference photograph 1).

1. View of typical entry monument and signage.

*Any mildew growth on the monuments and grout joints may be power washed as part of regular maintenance for a better appearance. It is recommended that \$15,000 be allocated for the repair, cleaning, and tuck pointing of the entry monuments and signage every eight years. It is also recommended that \$17,500 be allotted for the repair, cleaning, and tuck pointing of the brick veneer piers and fencing every eight years.*

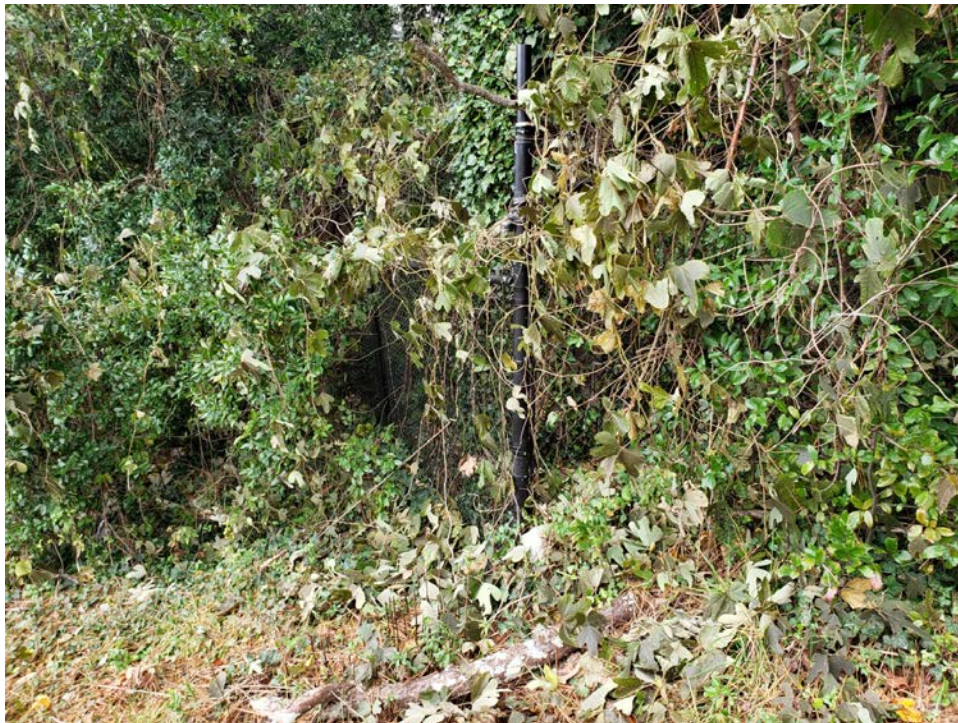
7. **Common Area Fencing** – The common fencing at the property generally consists of a perimeter painted, chain link fence. A chain link fence typically has a useful life of 30+ years, with proper maintenance. Typically, depreciation of the estimated useful life of the fence is caused by physical damage from a tree or vegetation, an individual, or wildlife. The paint will also begin to chip and fade over time and a new coat should be installed. At the time of our review, sections of the fence were covered by vegetation so all areas of the common area fencing were not evaluated (reference photograph 2). Our general observation found no evidence that would indicate any major problems and the fencing appears to be properly installed and maintained.

2. View of section of chain link fence that is covered by large amounts of vegetation.

*It is recommended that \$6,000 be allotted for the repair, painting and partial replacement of the common area fencing, as needed, approximately every six years.*

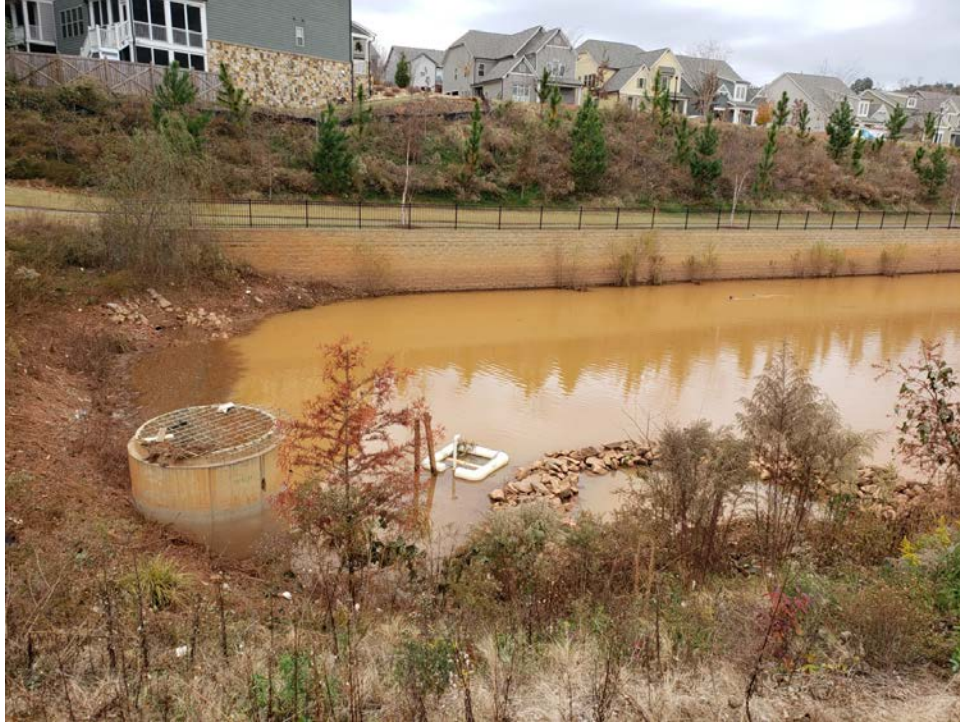
3. View of retention pond (lake).

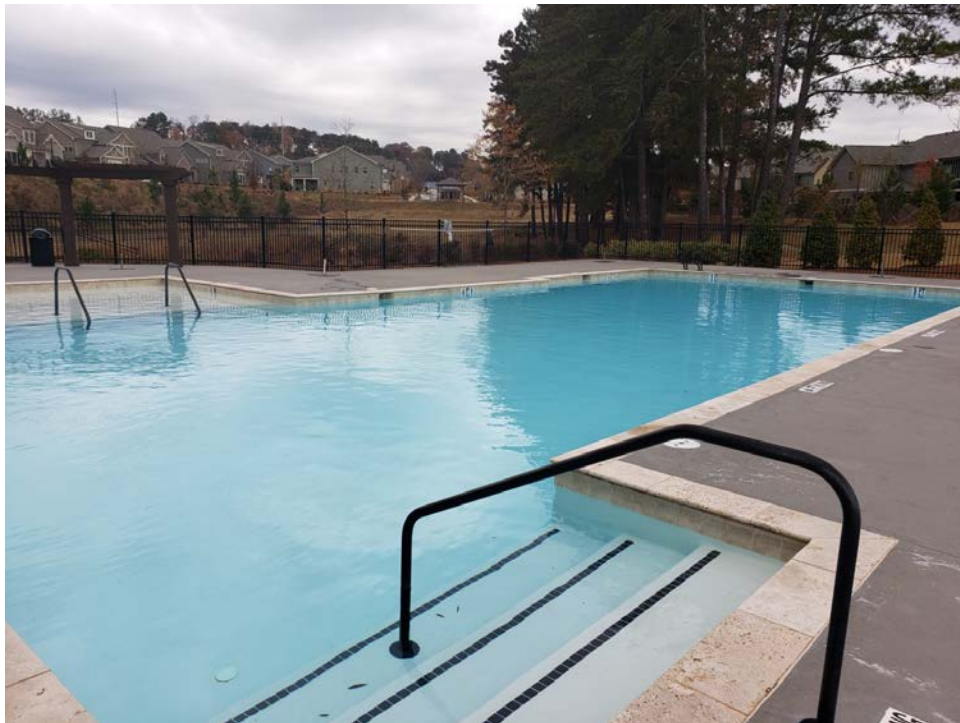
- 10. **Swimming Pool/Deck/Equipment** - The swimming pool consists of an in-ground concrete pool with plaster finish. The pool deck consists of a concrete slab-on-grade and is surrounded by a pre-finished aluminum picket fence. At the corner of the pool deck is a wood-framed arbor. From our review, the swimming pool and all corresponding components appeared to be in generally good condition; however, there is a linear crack along the pool surface and there a linear crack at the pool deck (reference photographs 4-6). It is our understanding that the crack

4. View of swimming pool and deck.

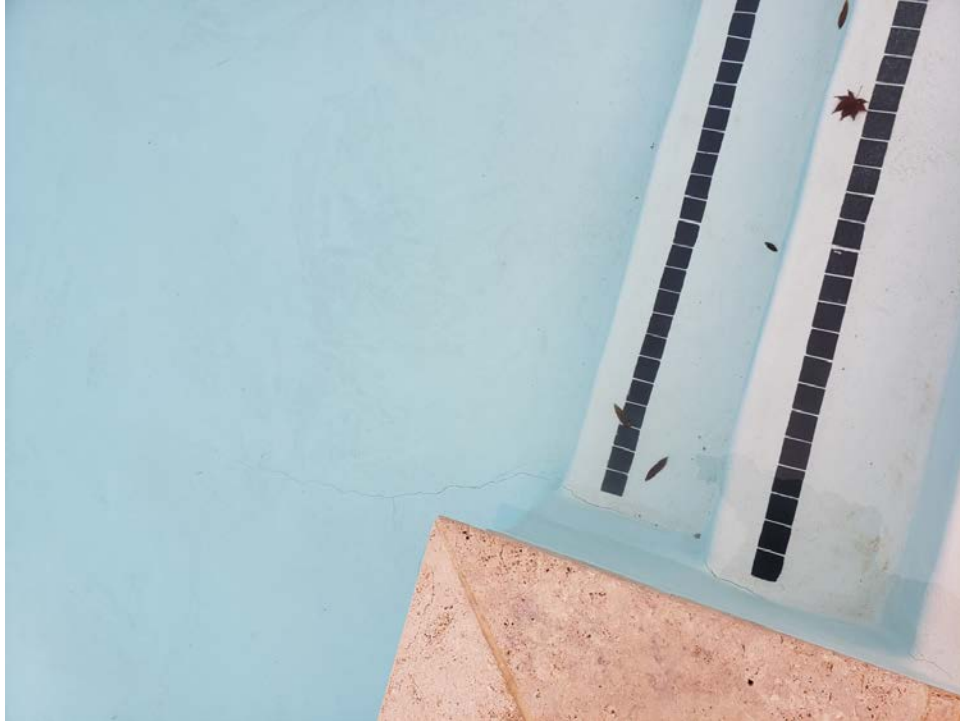
at the surface of the swimming pool may be increasing in size and should be further investigated to determine if the pool is settling and/or there is damage to the structural integrity of the pool. After the crack is investigated, proper repairs and patching should be conducted.

5. View of linear crack along the surface of the swimming pool.

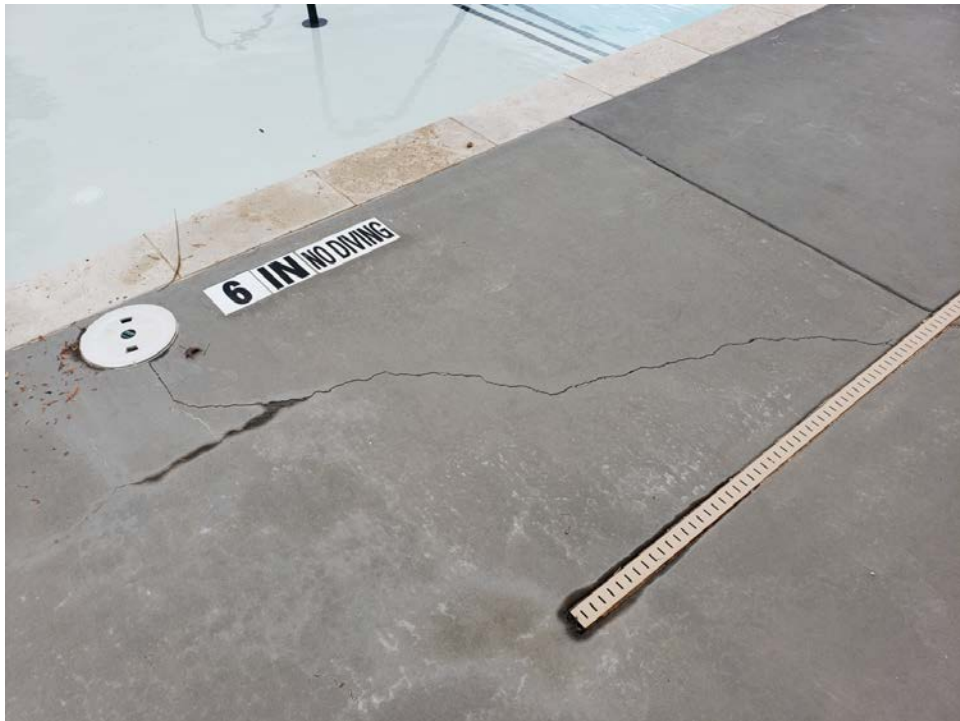
6. View of linear crack at the pool deck surface.

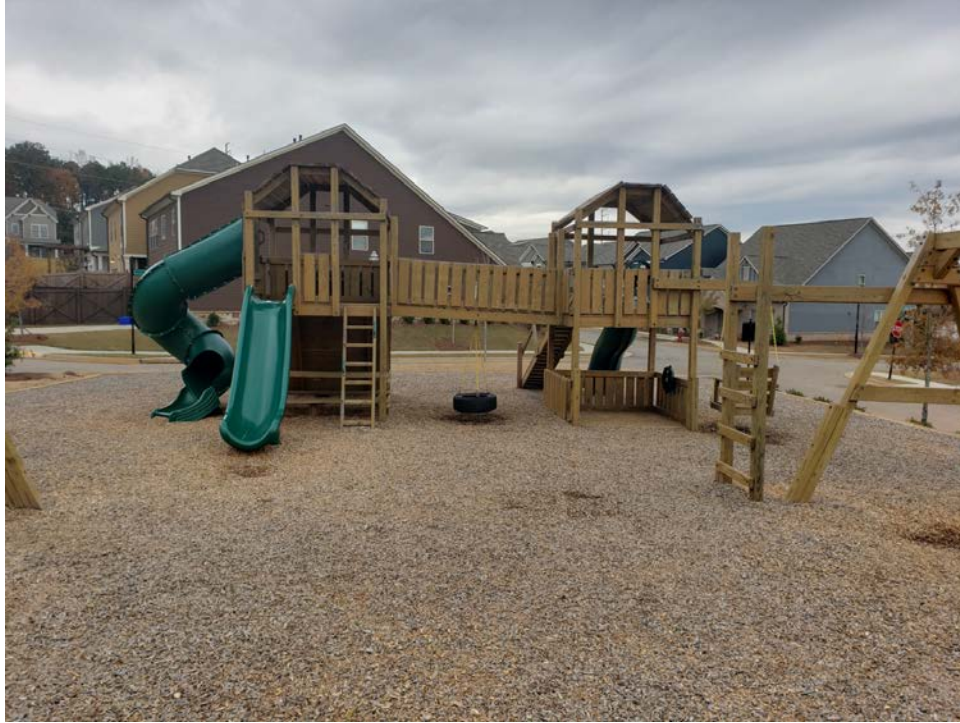
- 11. **Playground** – The playground equipment is located at the center of the property. Playground equipment consists of a wood-framed structure with polyethylene slides. From our review, the existing playground equipment appeared to be in generally good condition and structurally sound (reference photograph 7).

7. View of playground equipment.

*It is recommended that \$1,500 be allotted for the repair and partial replacement of the playground equipment every eight years. It is also recommended that \$10,000 be allotted for the replacement of the playground equipment every 20 years.*

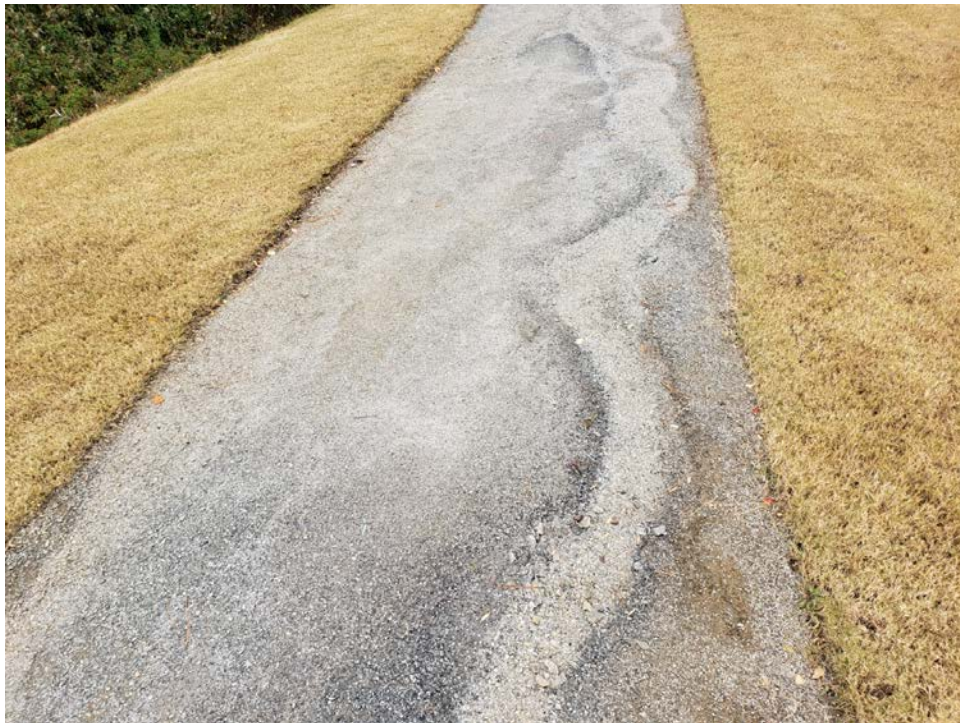
- 12. **Walking Trail** – There is a walking trail located along the perimeter of the retention pond. The walking trail consists of a resin material. It is our understanding that the walking trail may be replaced with a different material in the near future. From our review, the walking trail appeared to be in generally

good condition and installed properly; however, as a result of the recent heavy rain, sections of the trail have signs of erosion (reference photograph 8).

8. View of erosion along the walking trail.

*If sections of the trail show signs of erosion, it is recommended that the surface of the walking trail be re-graded. It is recommended that \$2,000 be allotted for maintenance of the walking trail approximately every five to six years.*

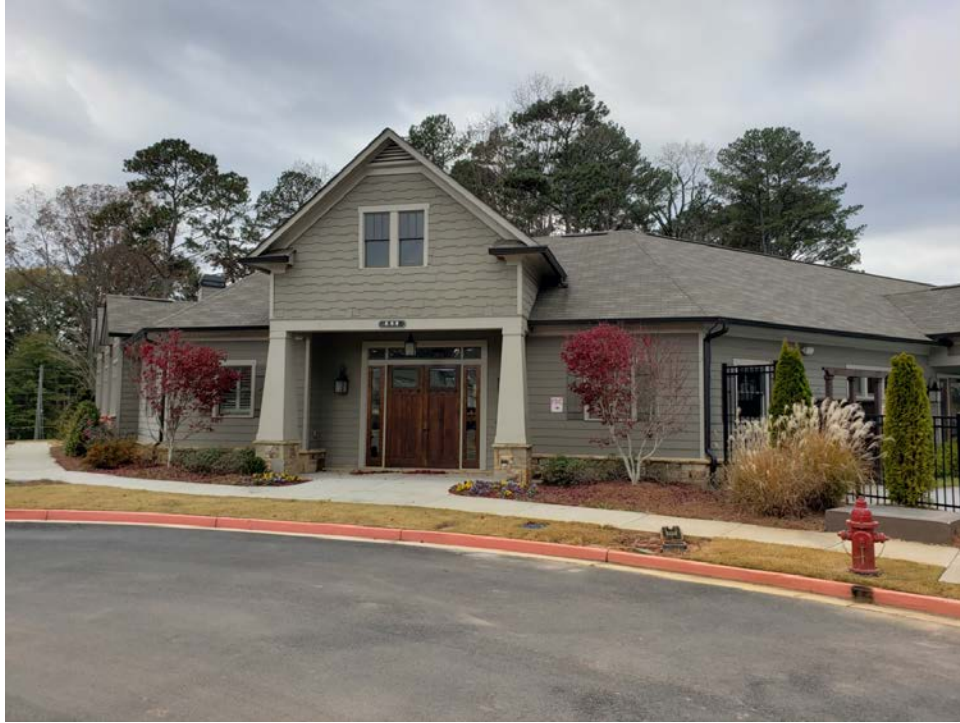
- 13. **Clubhouse** - The clubhouse is a one-story structure. The foundation of the clubhouse appears to be constructed utilizing monolithic concrete slab-on-grade with turned down edges supporting a one-story building structure of conventional wood-framed construction. Exterior finishes consist of painted cement board lap siding with painted wood, cement board trim, soffit, and fascia boards in combination with stone veneer accents. The roof is a steep-pitched hip roof system, sheathed with fiberglass based composition asphalt shingles. Roof runoff is controlled by gutters and downspouts around the perimeter eave of the roof. The interior of the clubhouse contains a great room, an office, a kitchen with appliances, two restrooms, an equipment room, a fitness room, a storage room, a pet washing station, and stone patio with a fireplace and grills. The interior finishes generally consist of a combination of painted gypsum board at the walls with painted wood bases, crown molding, doors, and trim. From our review, the clubhouse and all corresponding components appeared to be in generally good condition and installed properly with no obvious deficiencies observed (reference photographs 9-13).

9. View of front elevation of the clubhouse.

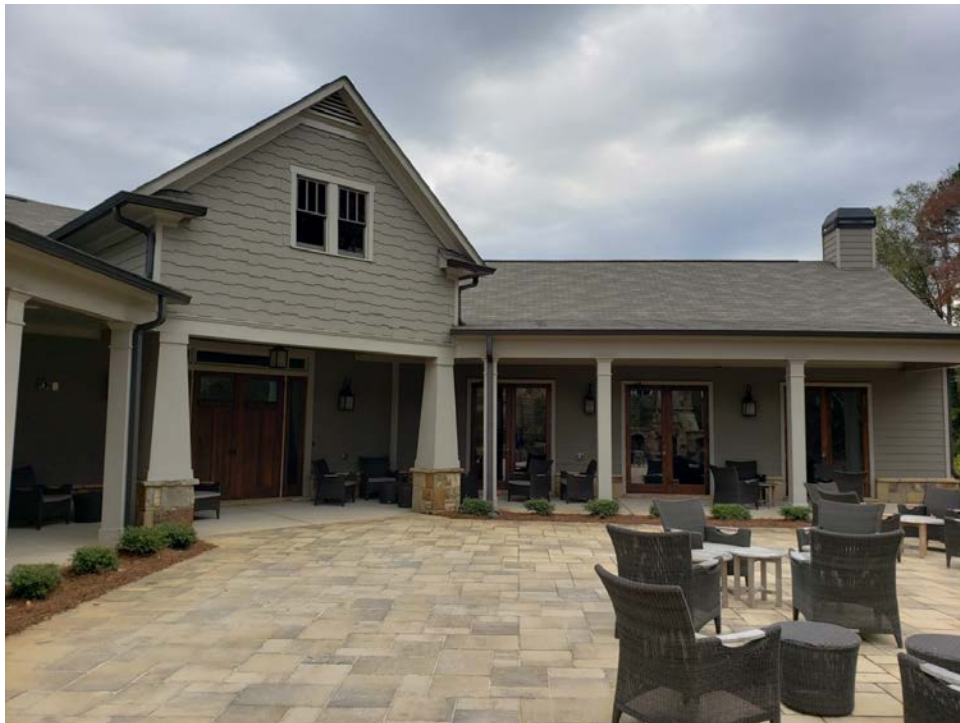
10. View of rear elevation of the clubhouse.

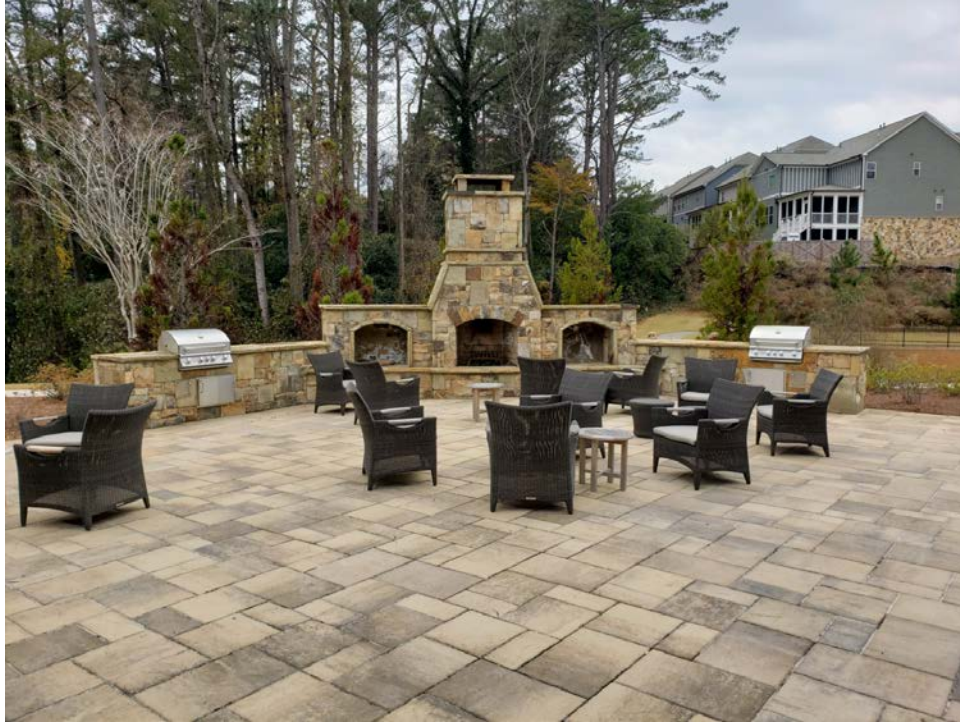
11. View of patio at the clubhouse.

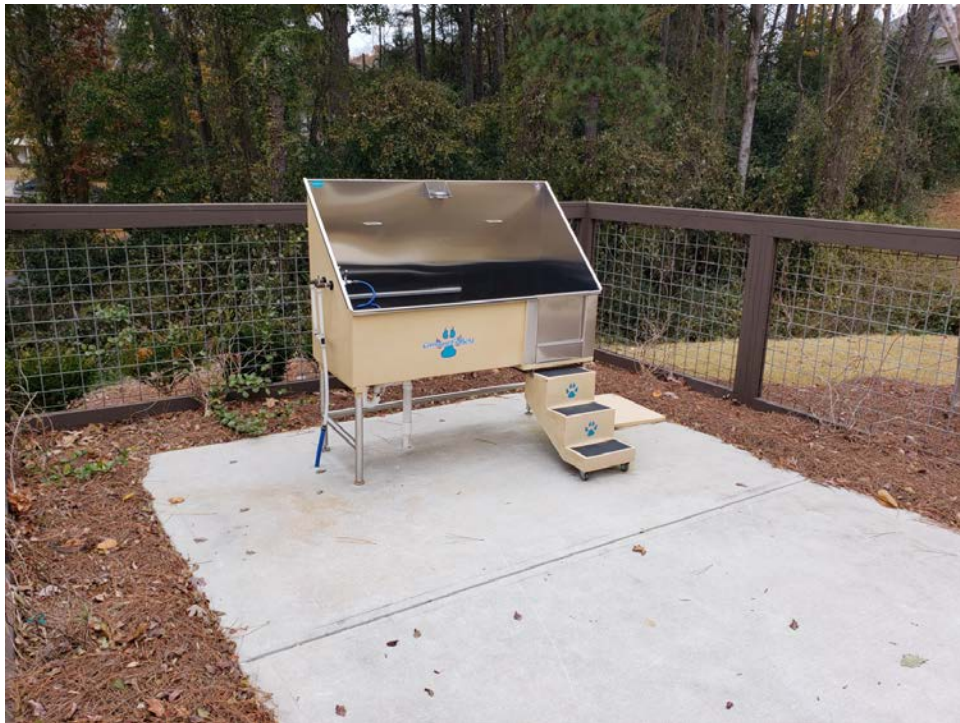
12. View of pet washing station.

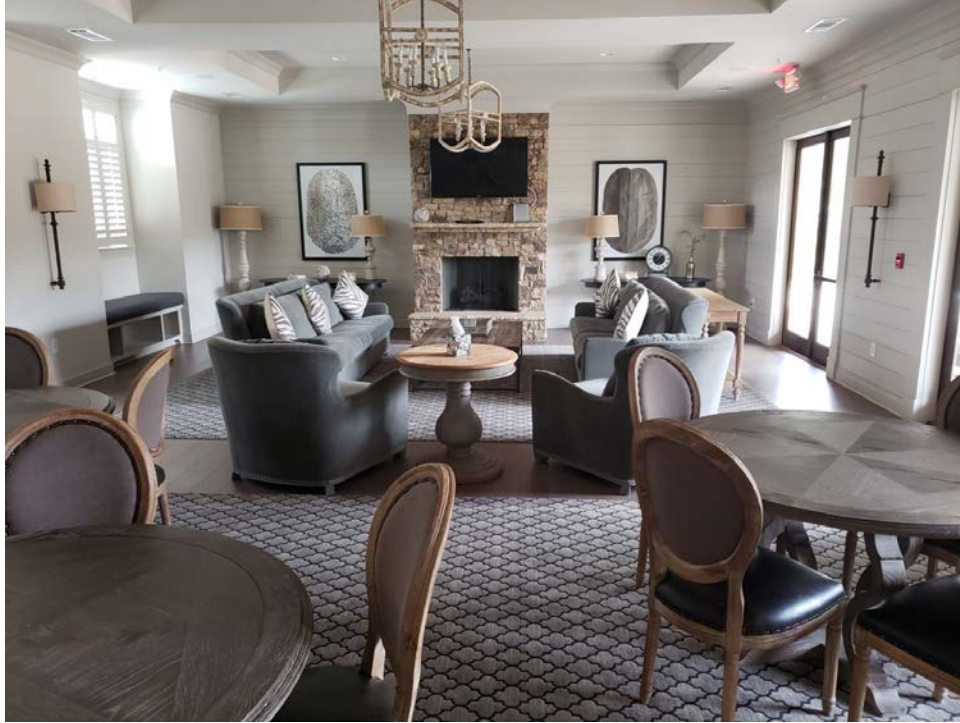
13. View of main event room at the clubhouse.

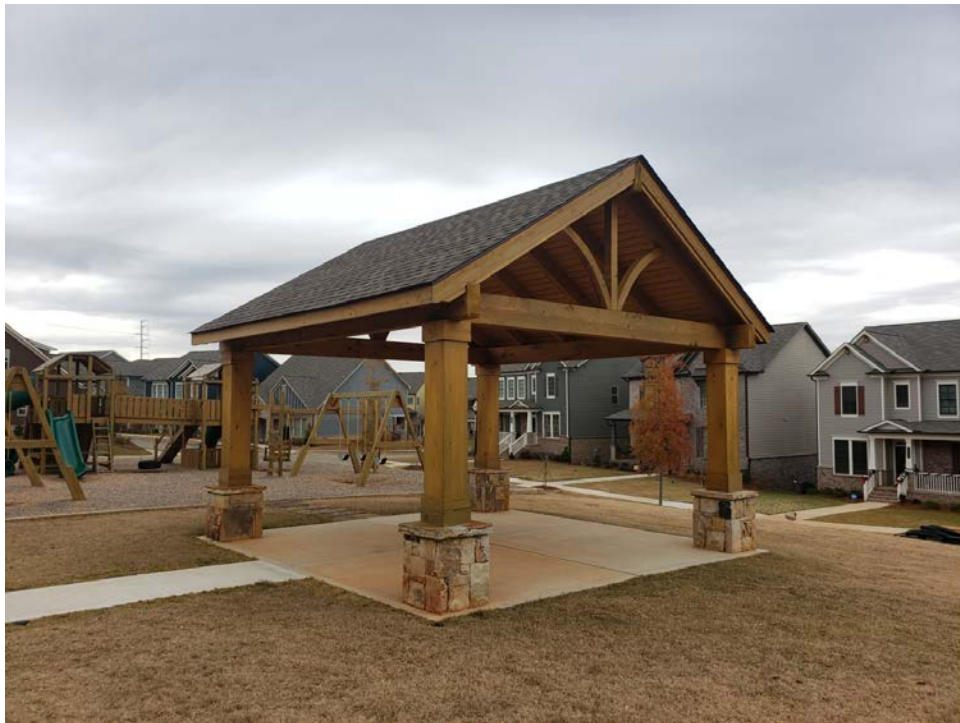
14. **Mailbox Kiosks/Pavilion** – There are two mail kiosks and one pavilion at the property. The mailbox kiosks and pavilion consist of wood-framed construction. The roofs consist of moderately steep-sloped roof with composition asphalt shingles. From our review, the mailbox kiosks and pavilion appeared to be in generally good condition and structurally sound; however, we observed cracks in the stone at the base of the columns at the mail kiosks (reference photographs 14-16).

14. View of pavilion.

*The cracks in the stone are minor and are typically repaired under the operating budget. It is recommended that \$3,300 be allotted for the replacement of the roofs every 20-25 years. A budget of \$3,000 is allotted for the repair and painting of the mail kiosks and pavilion exterior surfaces that should be completed, as needed, every nine to ten years.*

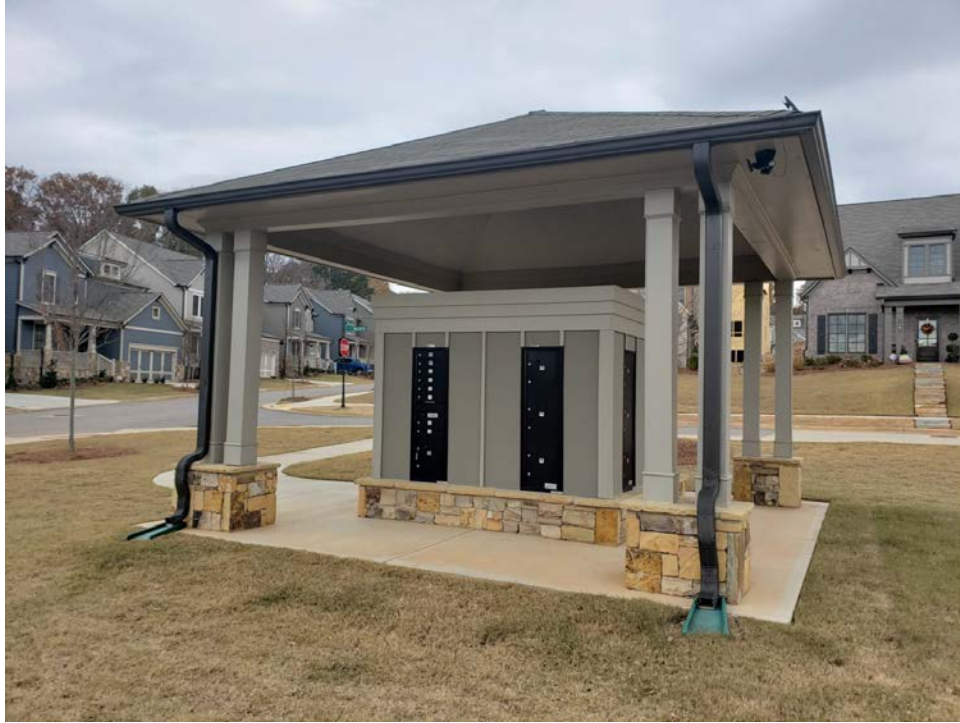
15. View of mailbox kiosk.

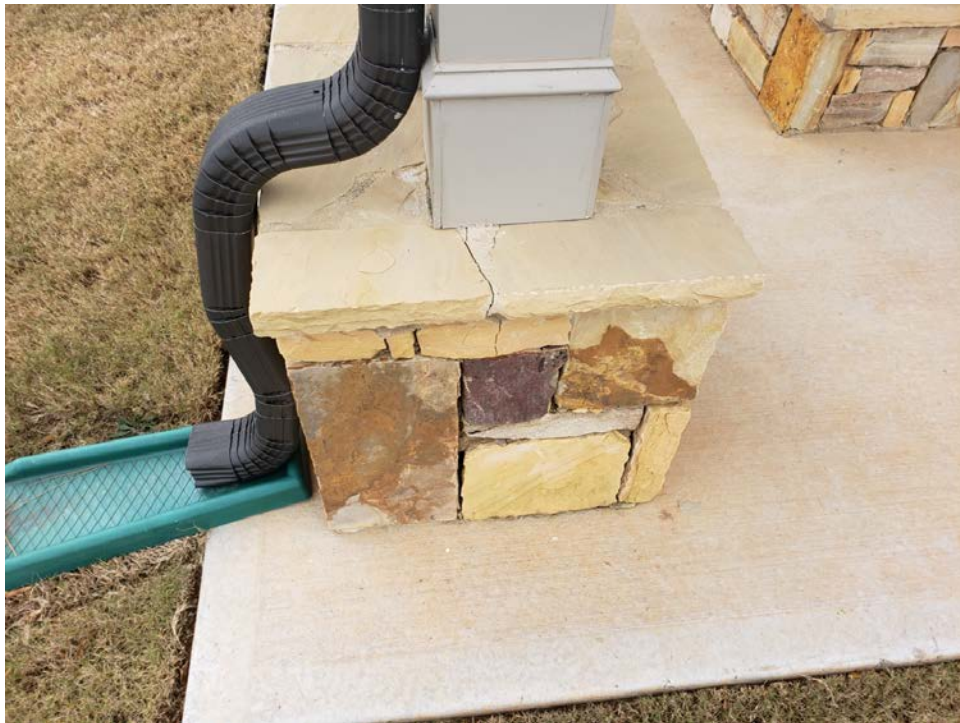
16. View of cracked stone at column of mail kiosk.

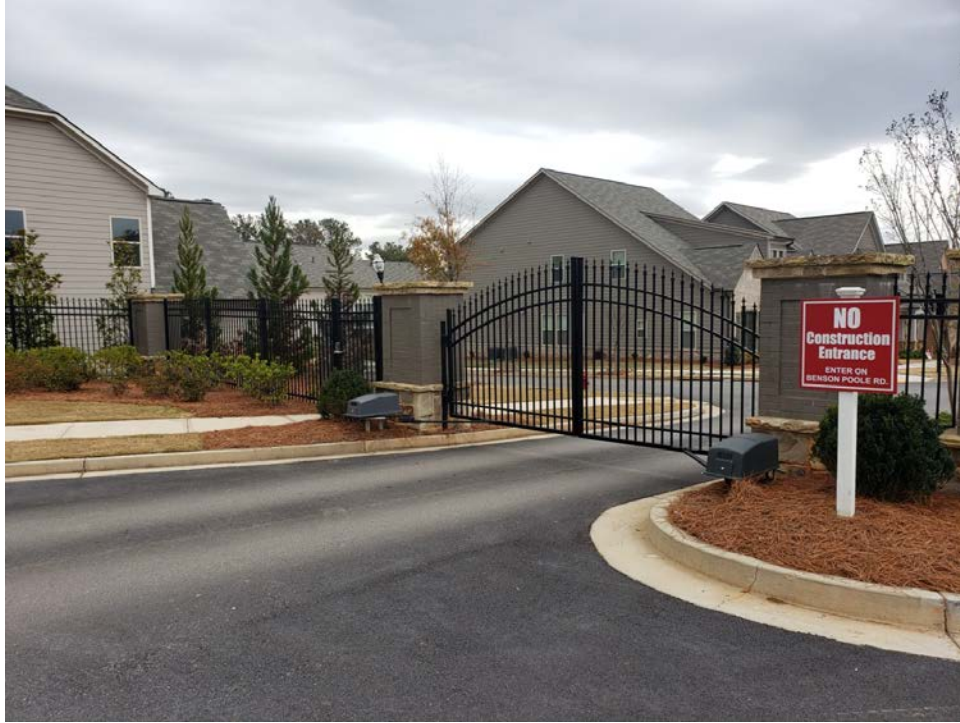
17. **Entry Gates/Controllers/Access System** – There are security gates at the property that consist of steel frame swinging gates that are mounted to the entry brick veneer piers. The directory/access system is located at the entrances to the property, at the center islands, that controls the security gates. It is our understanding that the Association may install additional gates in the near future. From our review, the entry gates and directory/access system appeared to be in generally good condition and operating properly with no obvious evidence found that would suggest any remedial work at this time. Due to changes in code compliance, technology and normal wear and tear, remote access systems and directories become obsolete and/or become lacking in new features. Most systems can be upgraded or modified as needed to keep-up with the changing requirements and features (reference photograph 17).

17. View of typical entry gate.
