SPECIMEN TREE REPORT

Tree Report for:
Prime Interest
4235 South Lee Street
Buford, GA 30518

Property Address:
4730 Camp Highland Rd. SE
Smyrna
Cobb County

Project 15227.00

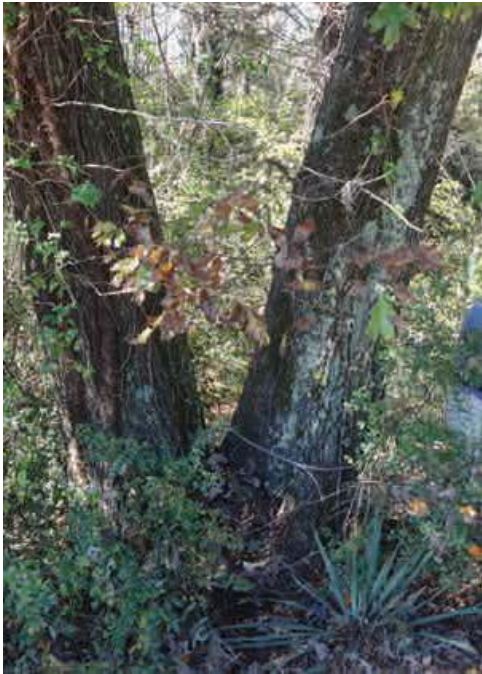
Pic # 1: Split with included bark and lean. DDH #1 & 2

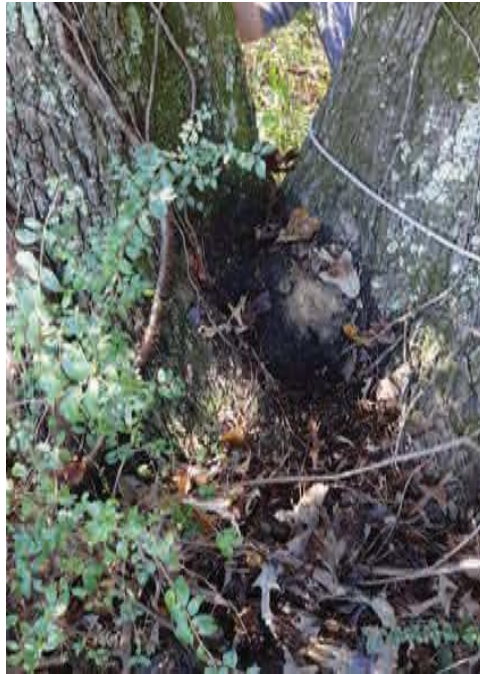
Pic # 2: Split with included bark, and lean. DDH #1 & 2

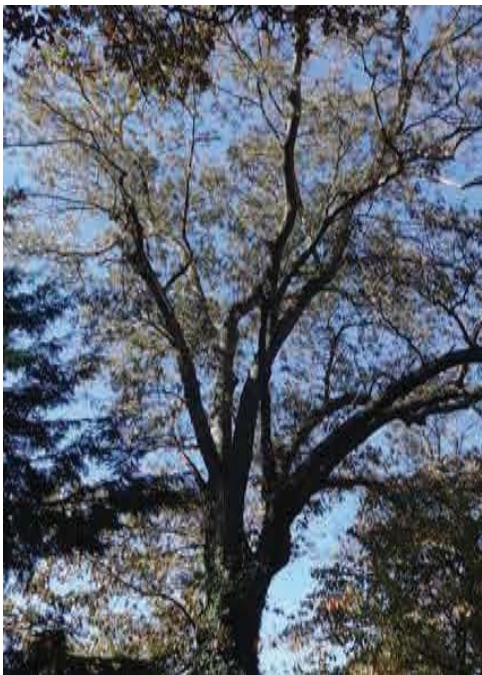
Pic # 3: Major dead limbs, decline, tip dieback. Less than 15 year life expectancy. DDH #3

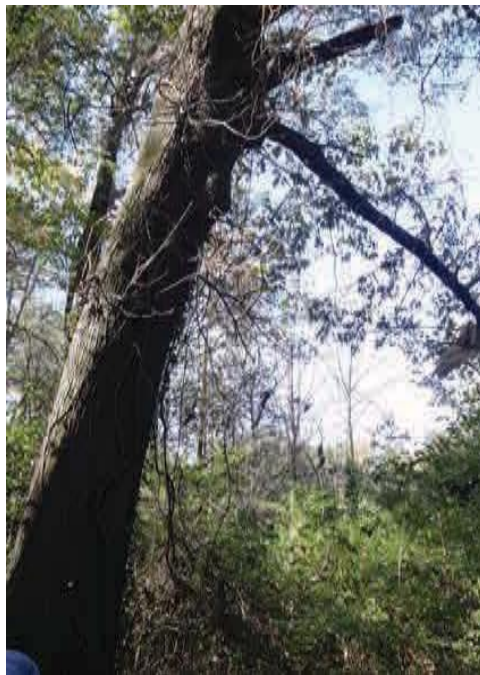
Pic # 4: Major lean, major limb loss. DDH #4

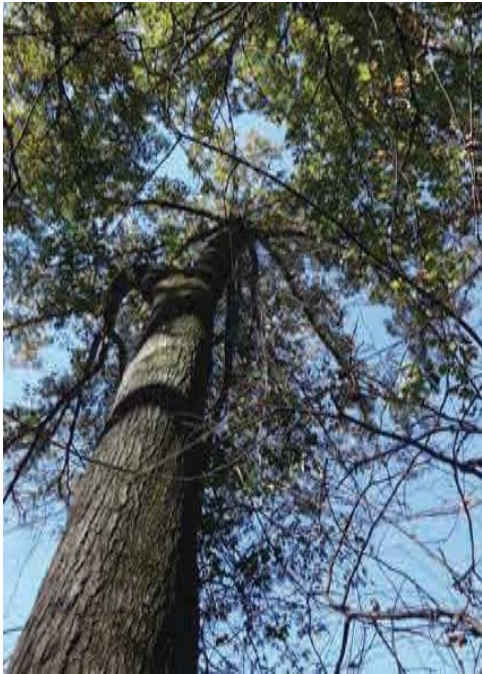
Pic # 5: Lean w/ 100% weight over lean. Root rot. DDH #5

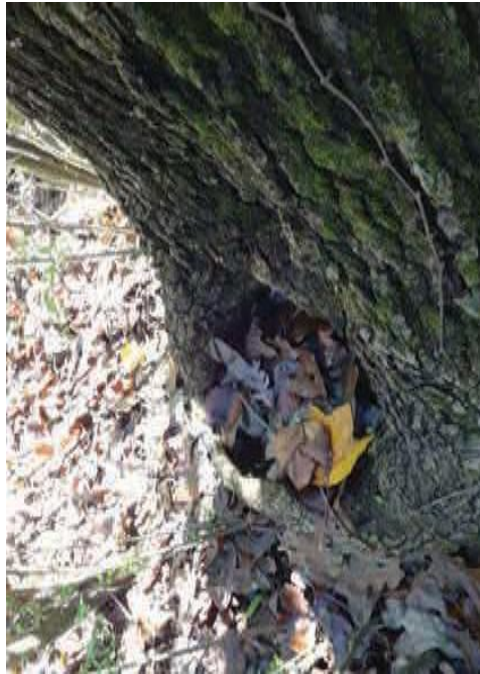
Pic # 6: Trunk wound. DDH #6

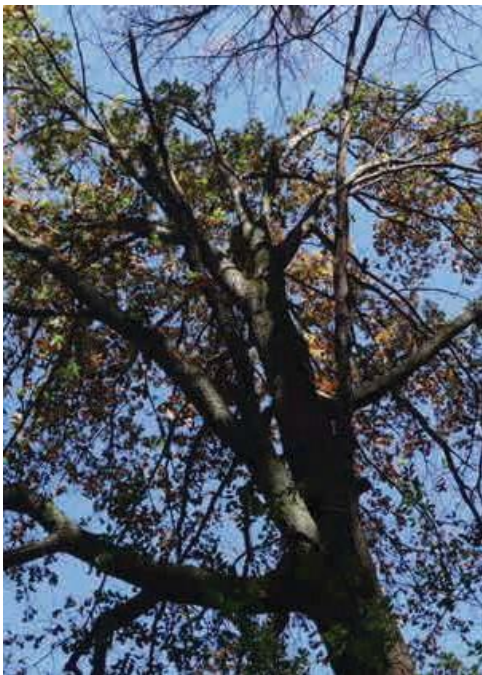
Pic # 7: Lean w/ weight over lean. DDH #6

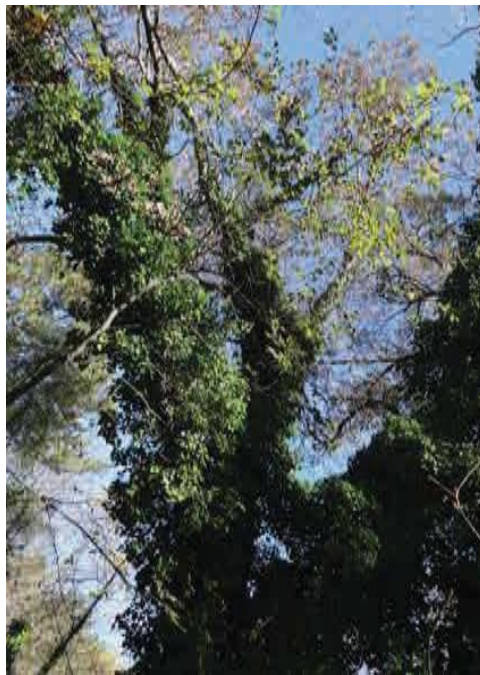
Pic # 8: Overall decline, tip dieback, and major limb loss. DDH #7

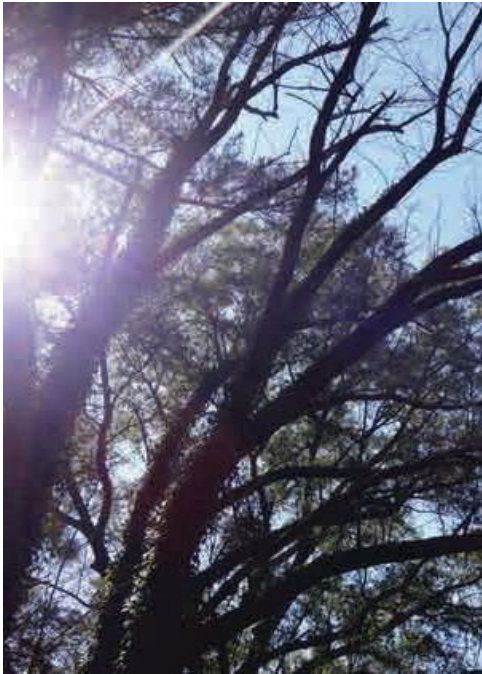
Pic # 9: Split mulit-leader. Decline and tip dieback DDH #9

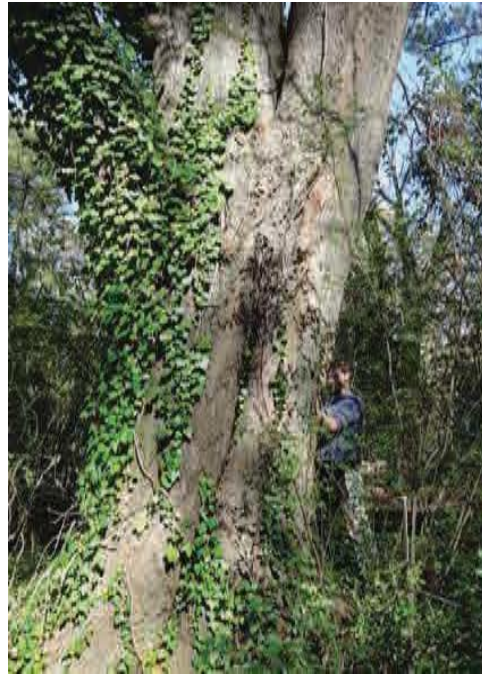
Pic # 10: Split with weeping. DDH #9

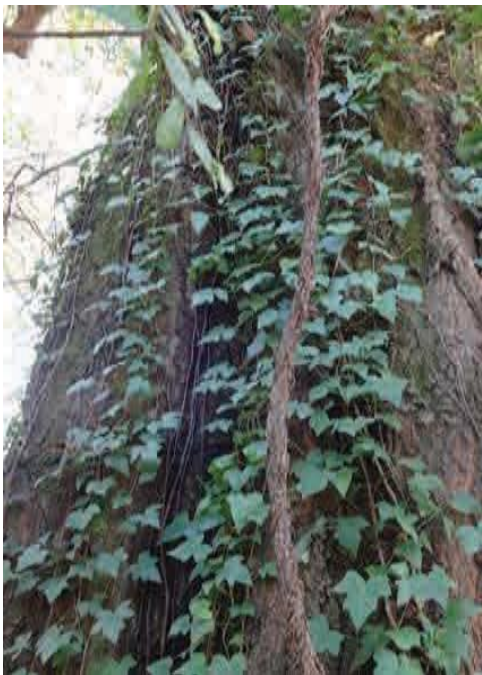
Pic # 11: Split with weeping. DDH #9

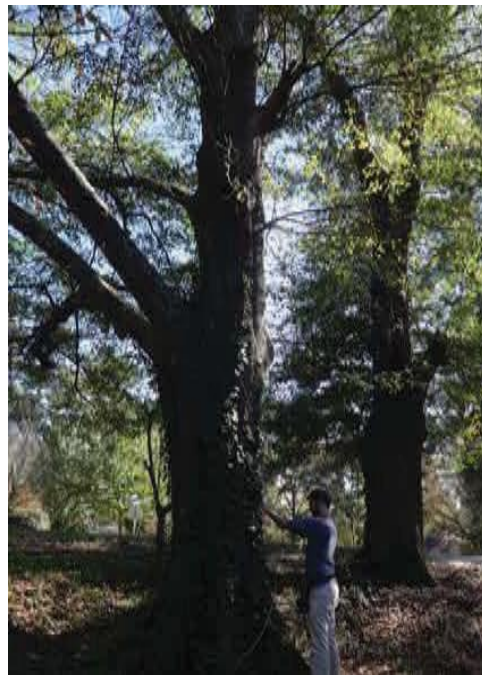
Pic # 12: Fruiting bodies on roots and major limb loss. DDH #10

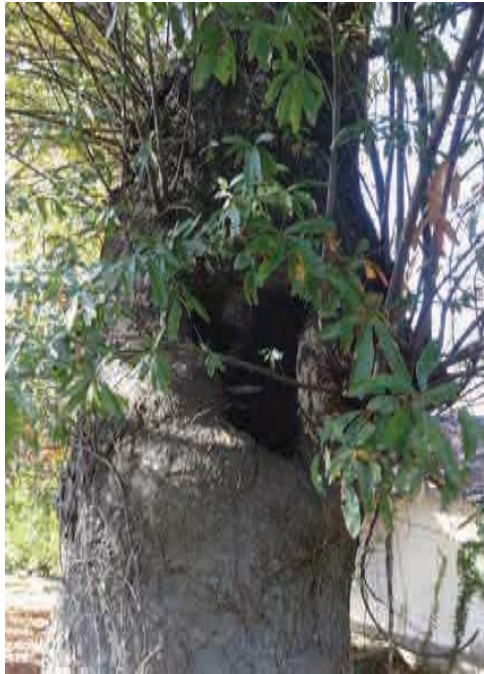
Pic # 13: Major trunk wound.
DDH #11

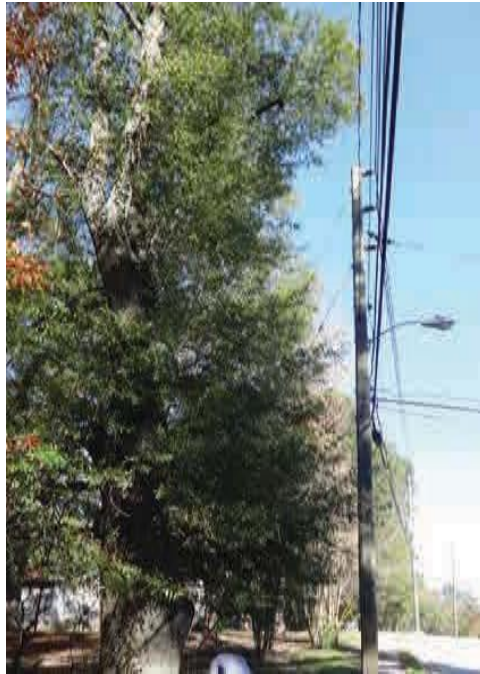
Pic # 14: Utility prune. DDH #11

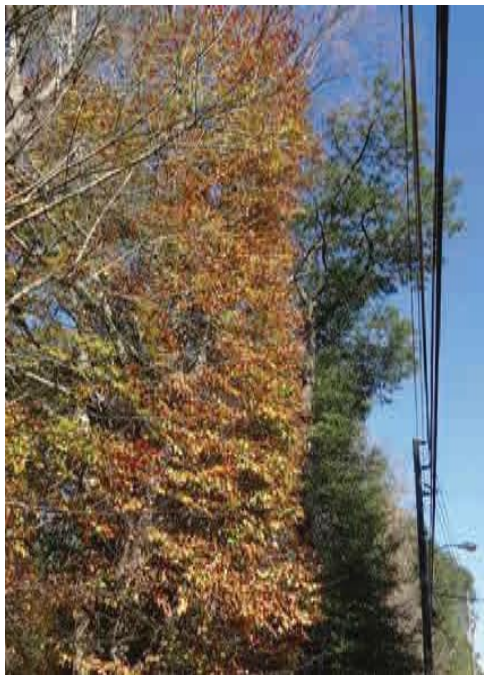
Pic # 15: Utility prune and weeping
wounds. DDH #12

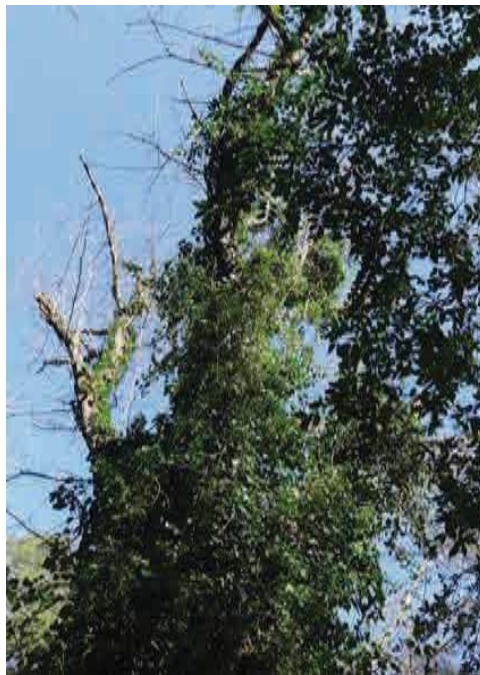
Pic # 16: Dead. DDH #13

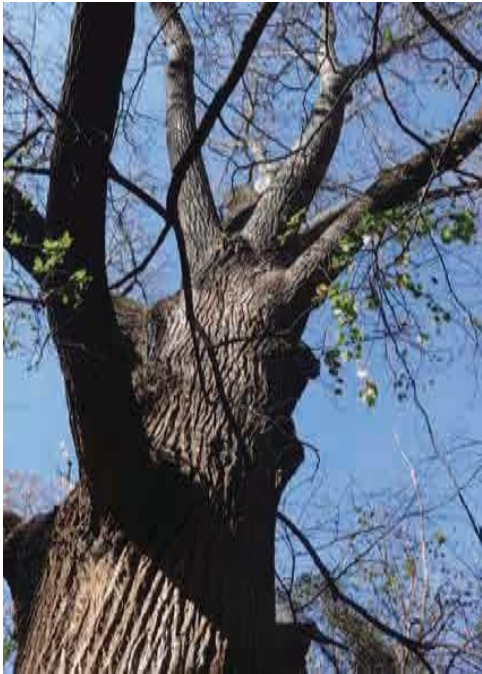
Pic # 17: Major limb loss. Decline with weeping trunk wounds at 25'. DDH #14

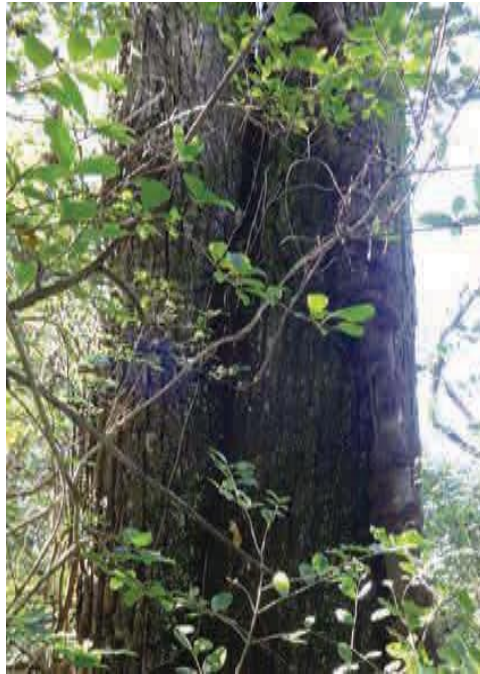
Pic # 18: Split with included bark. DDH #15

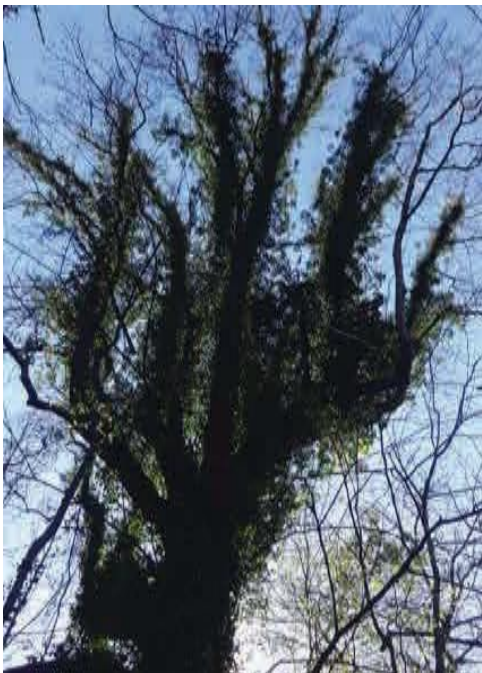
Pic # 19: Total ivy coverage and major dead limbs. DDH #16

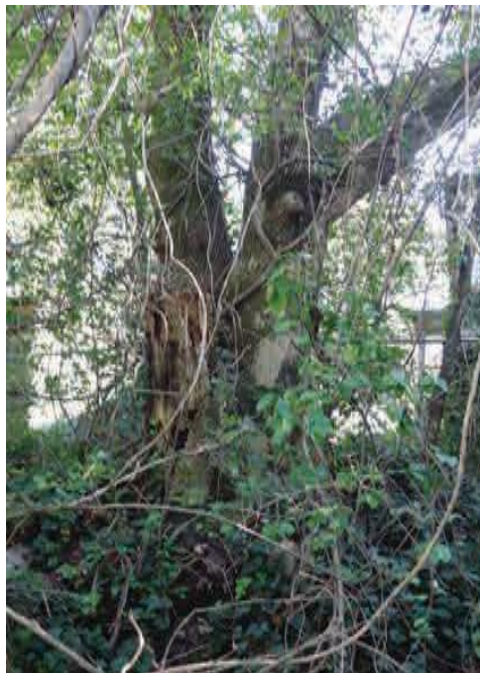
Pic # 20: Invasive, included bark, and major limb failure. DDH #17
