SPECIMEN TREE REPORT

Tree Report for:
Beazer Homes
6455 Shiloh Road Ste.A
Alpharetta, GA 30005

Property Address:
O Pebblebrooke Road
Smyrna GA

Project 19102.00A

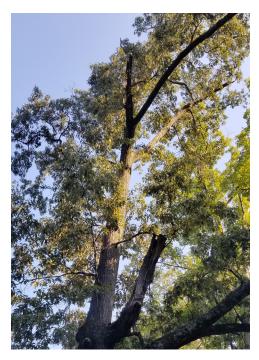
Pic # 1: Multiple dead major Branches NST #1

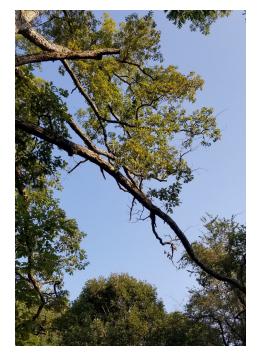
Pic # 3: Broken and dead major branches. NST #3

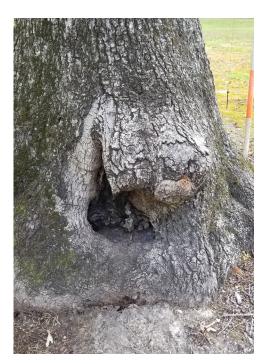
Pic # 4: Trunk wound with visible decay. NST #3

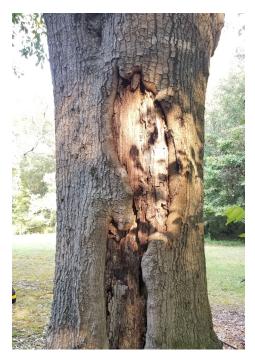
Pic # 5: Trunk Wound with visible decay NST #4

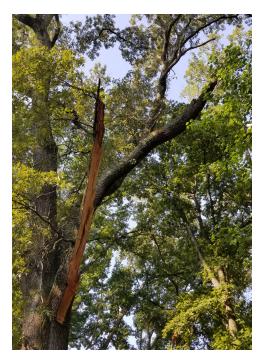
Pic # 7: Multiple dead major Branches NST #6

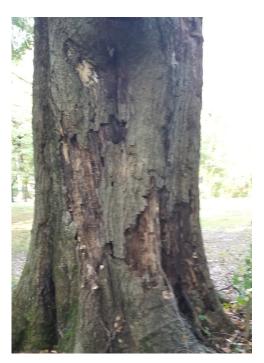
Pic # 6: Trunk wound with visible decay NST #5

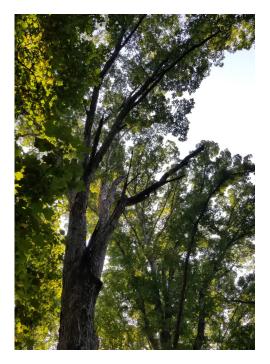
Pic # 8: Over 50% of canopy is dead NST #7

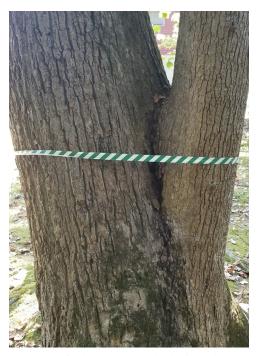
Pic # 9: Split with Included bark NST #8

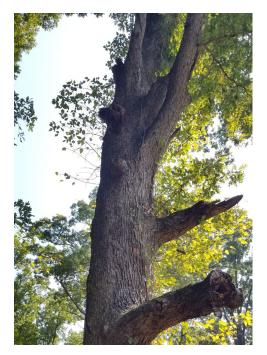
Pic # 11: Multiple dead major Branches NST #10

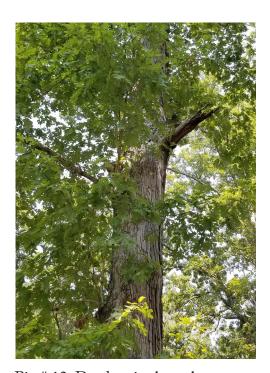
Pic # 12: Dead major branches NST #11

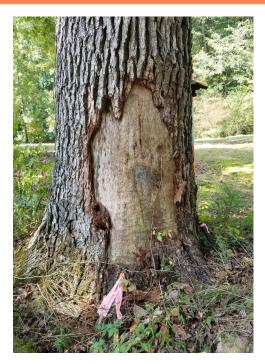
Pic # 13: Trunk wound NST #12

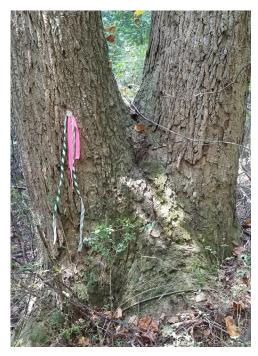
Pic # 15: Split with included bark NST #14

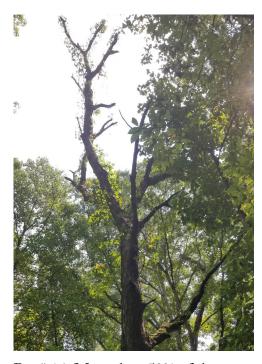
Pic # 16: More than 50% of the canopy is dead NST #15

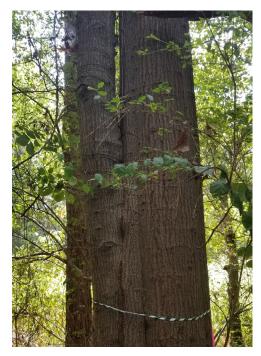
Pic # 17: Split with included bark NST #16

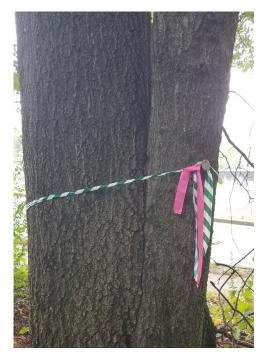
Pic # 18: Split with Included bark NST #17
